Manhole Inspection Summary

Manhole # S150__005MH

Insp Date: **4/4/08 10:45 AM**

Location Address: **2709 brunswick st**

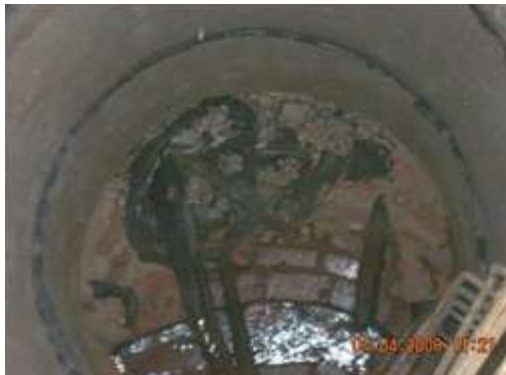
Defect 3

Condition: ☐ Sound ☐ Cracked ☐ Root Intrusion ☐ Deteriorated ☐ Leaks ☒ **Debris**

Count: **12** Missing: **0** ☒ **Corroded**

debris on bench, corroded steps

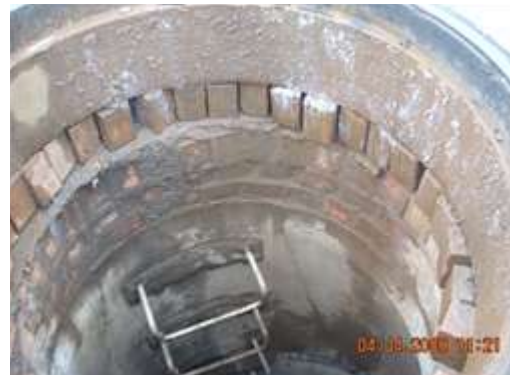
Defect 2

Infiltration: ☐ None ☒ **Joint** ☐ Cracks ☐ Mortar ☐ Roots ☐ Wall

infiltration @ chimney joint

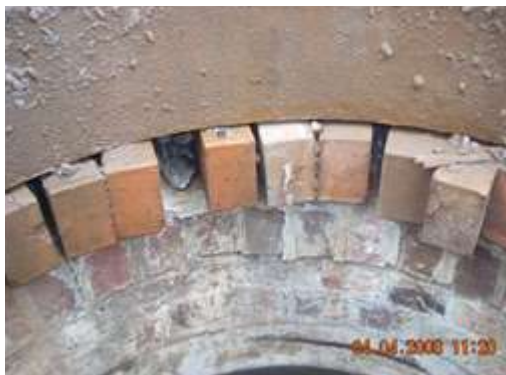
Defect 1

Condition: ☐ Sound ☐ Cracked ☐ Root Intrusion ☒ **Loose Brick** ☐ Deteriorated

loose chimney bricks

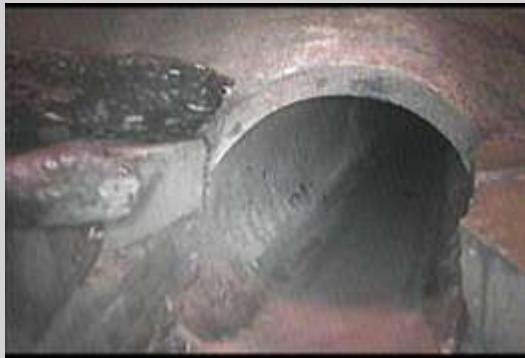
12 O'Clock Outflow

8 in. Circular Gravity Sewer
Pipe Out @ 12 O'Clock

Invert Depth: **15.75** (ft.) Flow Characteristics: **Slow**

Infiltration: **None** Pipe Seal Cond: **Sound**

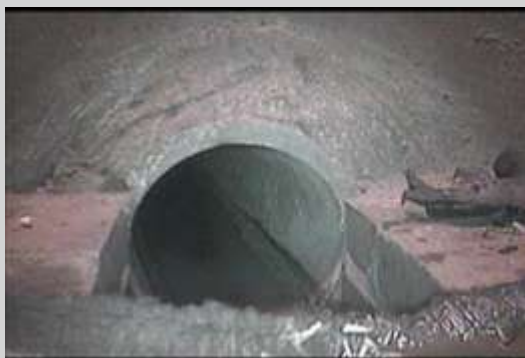
4 O'Clock Inflow

8 in. Circular Gravity Sewer
Pipe In @ 4 O'Clock

Invert Depth: **15.65** (ft.) Flow Characteristics: **Slow**

Infiltration: **None** Pipe Seal Cond: **Sound**
